Eccleshall Parish Council Speed Indicator Devices

Review and analysis, April, 2023 prepared by Cllr Ant Reid

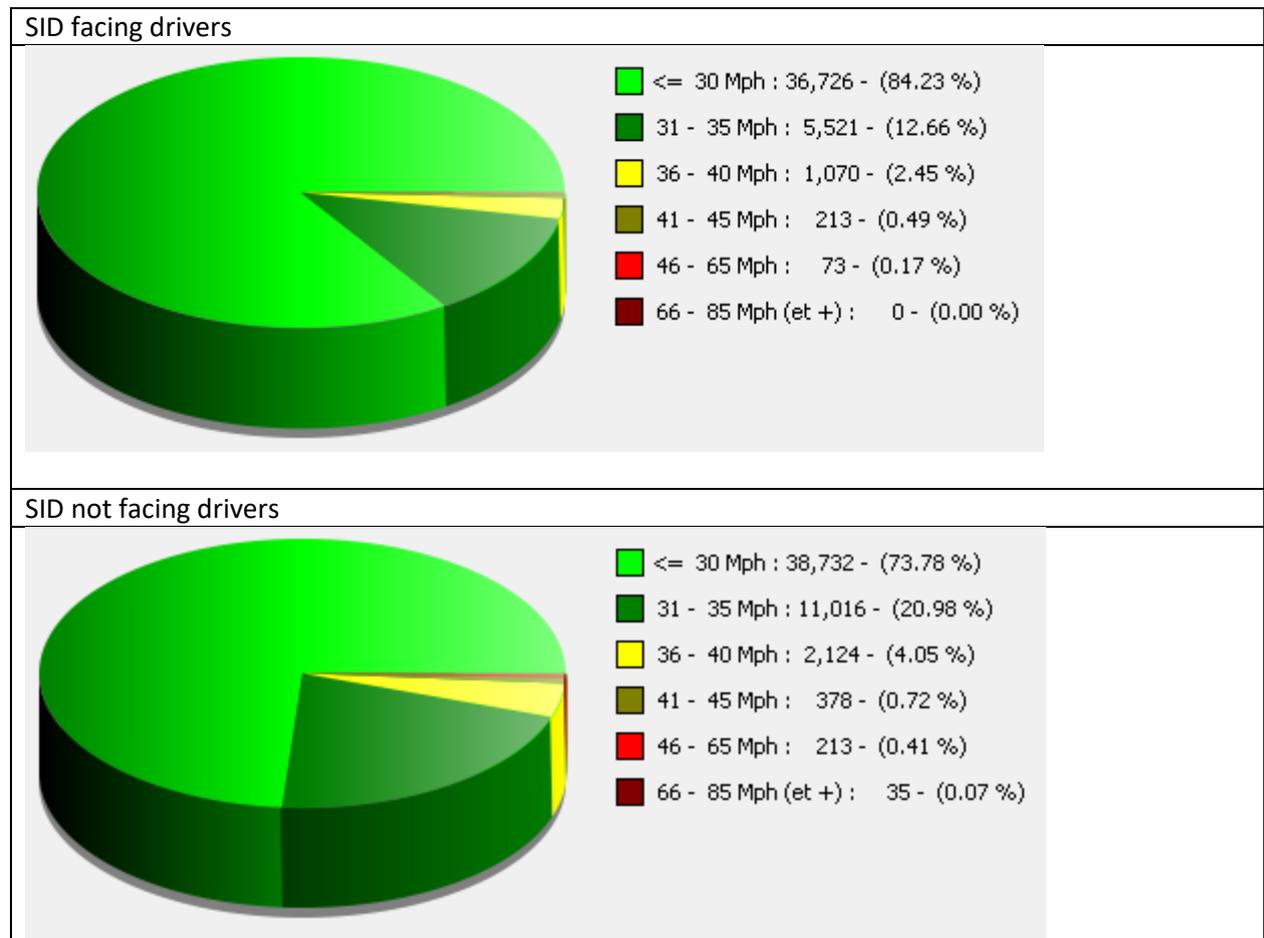
Stone Road: Vehicles leaving town

Two graphs showing vehicle speeds when driving east, towards Stone:

This shows that having the SID improves compliance by over 10%, and decreases excessive speed slightly.

The SID is having a measurable impact on compliance

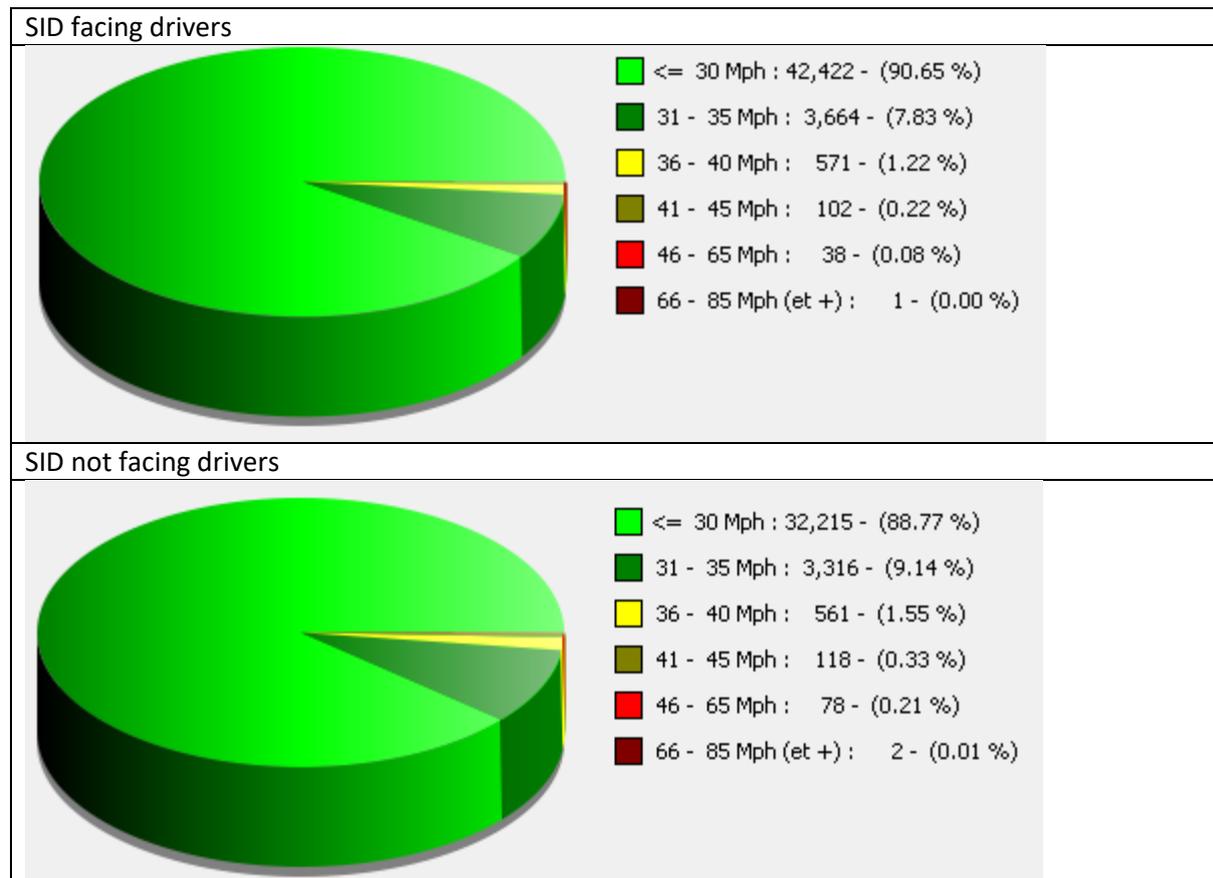
Stone Road: Vehicles entering town

Two graphs showing vehicle speeds when driving west, towards Eccleshall:

This shows negligible impact – the compliance is already high and does not change much when the SID is facing the driver.

The SID is having a negligible impact on drivers' speeds.

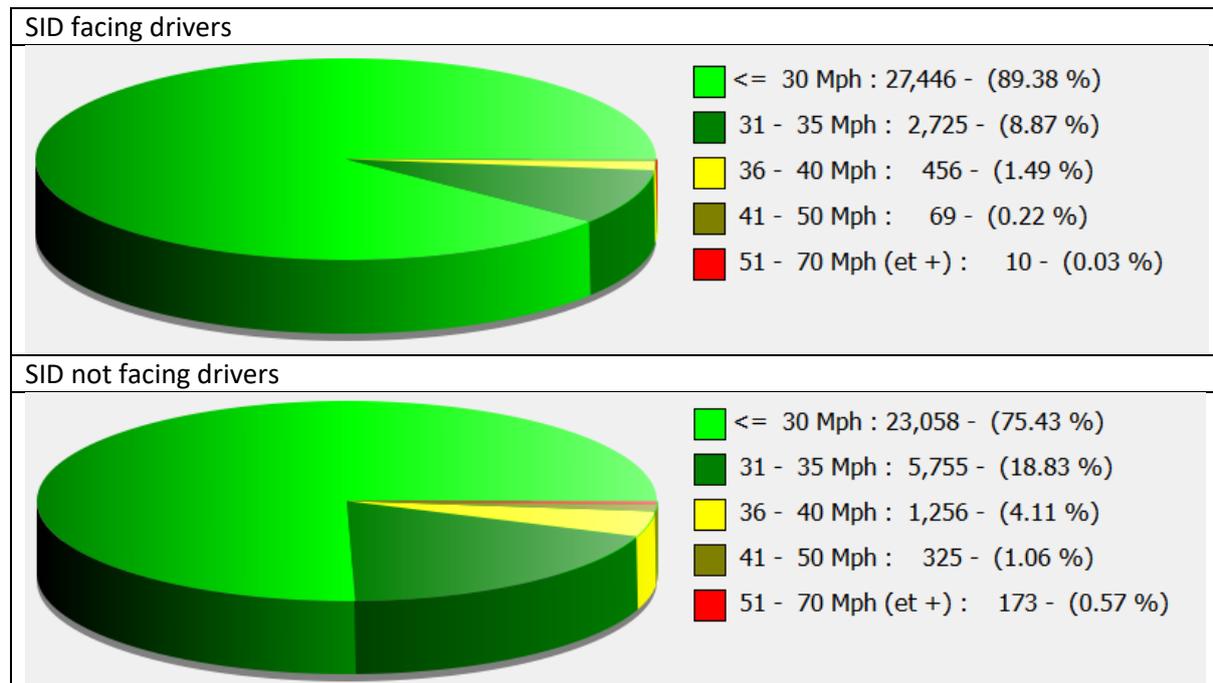
Croxton: vehicles heading east

Two graphs showing vehicle speeds when driving east, towards Eccleshall:

This shows that having the SID improves compliance by over 14%, and decreases excessive speed significantly (by several hundred vehicles per month).

The SID is having a measurable impact on compliance

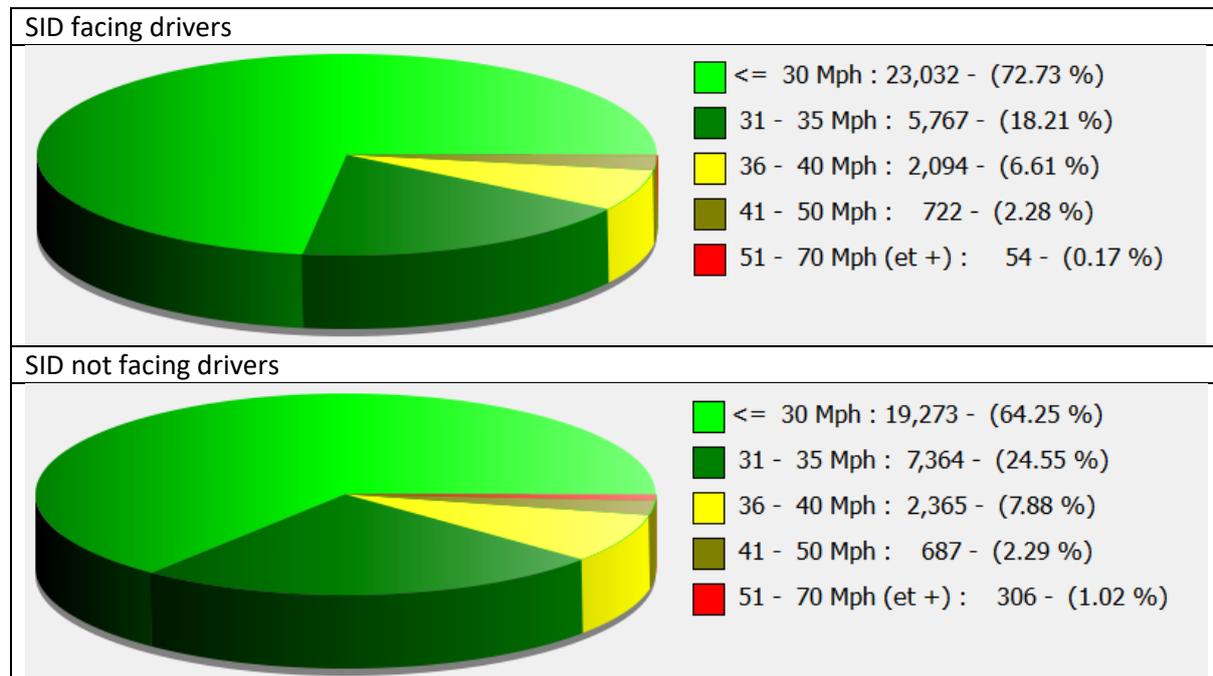
Croxton: vehicles heading west

Two graphs showing vehicle speeds when driving west, towards Loggerheads:

This shows that having the SID improves compliance by about 6%, and decreases excessive speed somewhat). However, overall compliance is still relatively low at 72% and excessive speeding is relatively high at over 2%. This data is broadly consistent across other months at different times of the year.

The SID is having a small impact on compliance

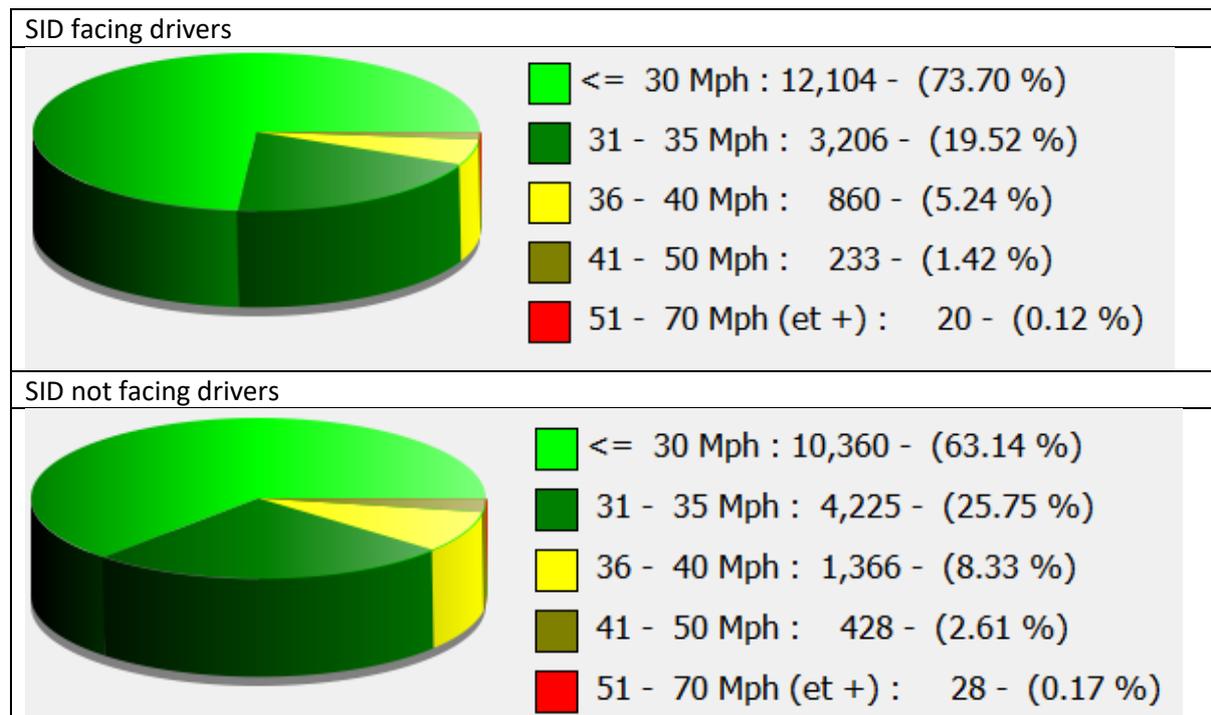
Green Lane: Vehicles heading East

Two graphs showing vehicle speeds when driving east, towards the Stafford Road:

This shows that having the SID improves compliance by over 10%, and decreases excessive speed by over 1%. However, compliance is still only approximately 74% and still several hundred vehicles a month travel excessively fast along this road.

The SID is having a measurable impact on speed compliance.

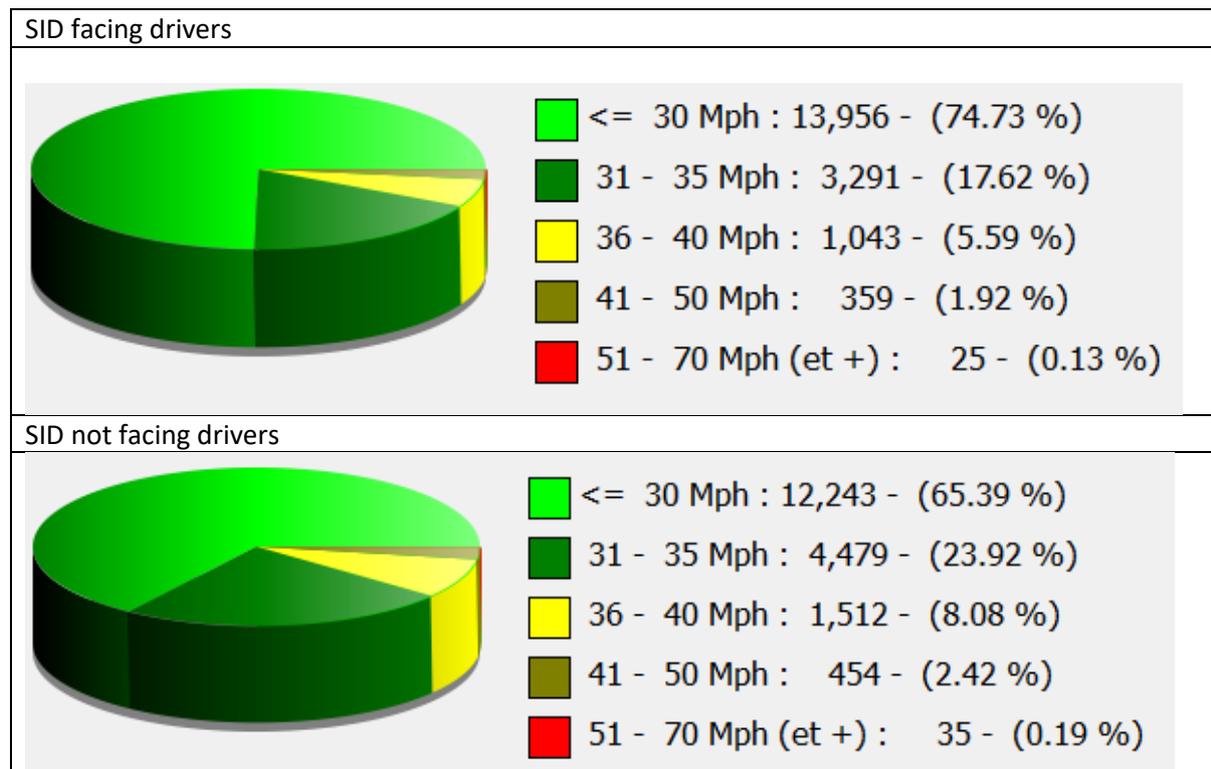
Green Lane: Vehicles heading West

Two graphs showing vehicle speeds when driving west, towards the Newport Road:

This shows that having the SID improves compliance by nearly 10%, and decreases excessive speed slightly. However, compliance is still only approximately 75% and still several hundred vehicles a month travel excessively fast along this road.

The SID is having a measurable impact on speed compliance.

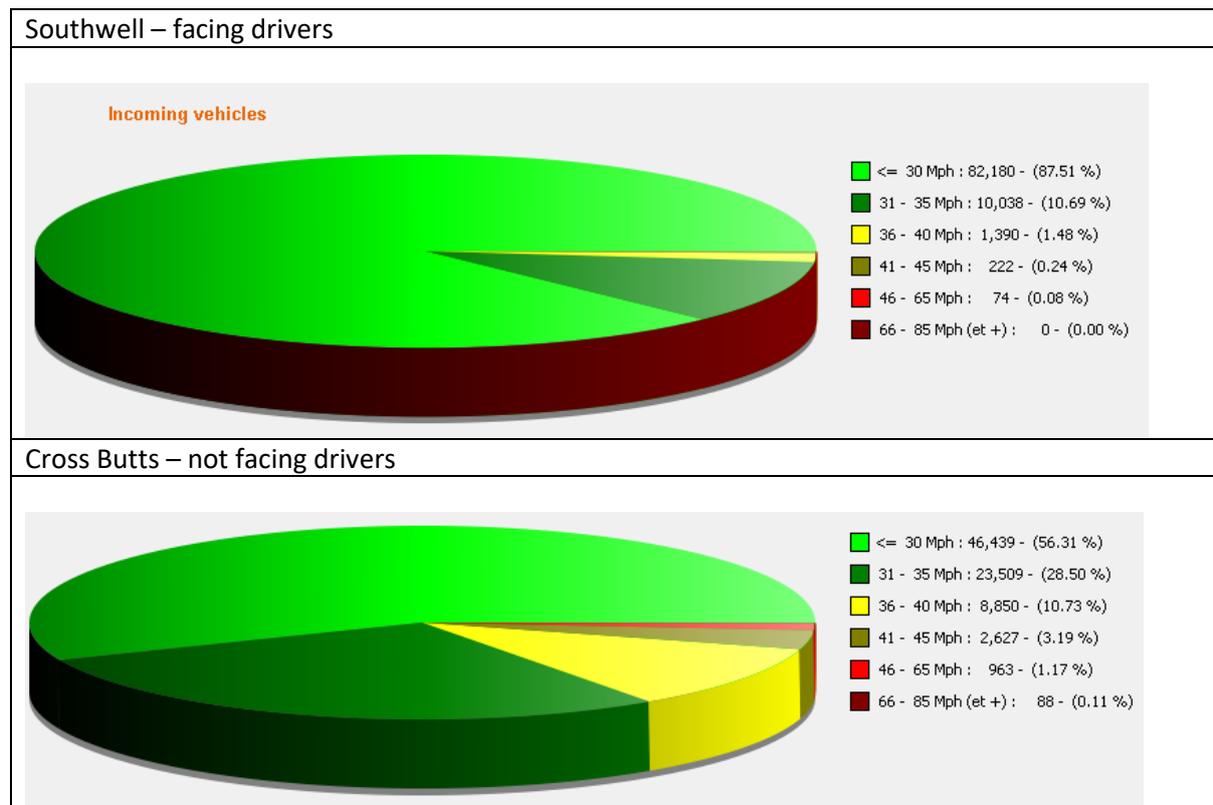
Newport Road – Vehicles leaving town

Two graphs showing speeds of vehicles traveling uphill – measured at the bottom and top of the hill:

There is a large drop in compliance between the bottom and top of the hill, with over three thousand vehicles driving excessively (over 40MPH) at the Cross Butts crossroads (over 4%).

It may be useful to rotate this SID to face downhill, and do further analysis on the data to identify patterns to the issue (such as time of day or day of week).

It is worth noting that still over 80% of vehicles travel below 35 MPH when reaching the edge of the town. In absolute terms that is relatively good compliance.

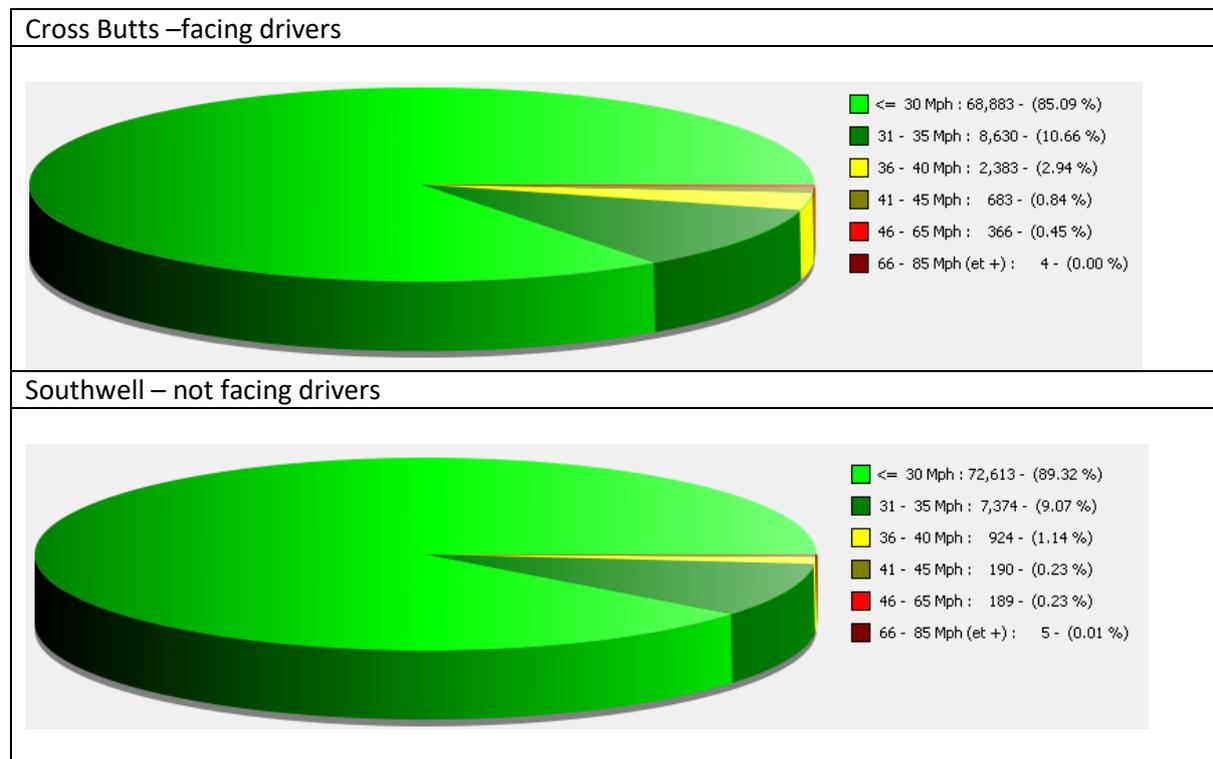
Newport Road – Vehicles entering town

Two graphs showing speeds of vehicles traveling downhill – measured at the top and bottom of the hill:

Very good compliance at both top and bottom of the hill. Data is only collected from the top of the hill when the SID is facing downhill drivers, so it is not possible to determine the impact of the SID (we never measure speed when the SID is not facing drivers). Rotating the SID for a month may enable better analysis of this.

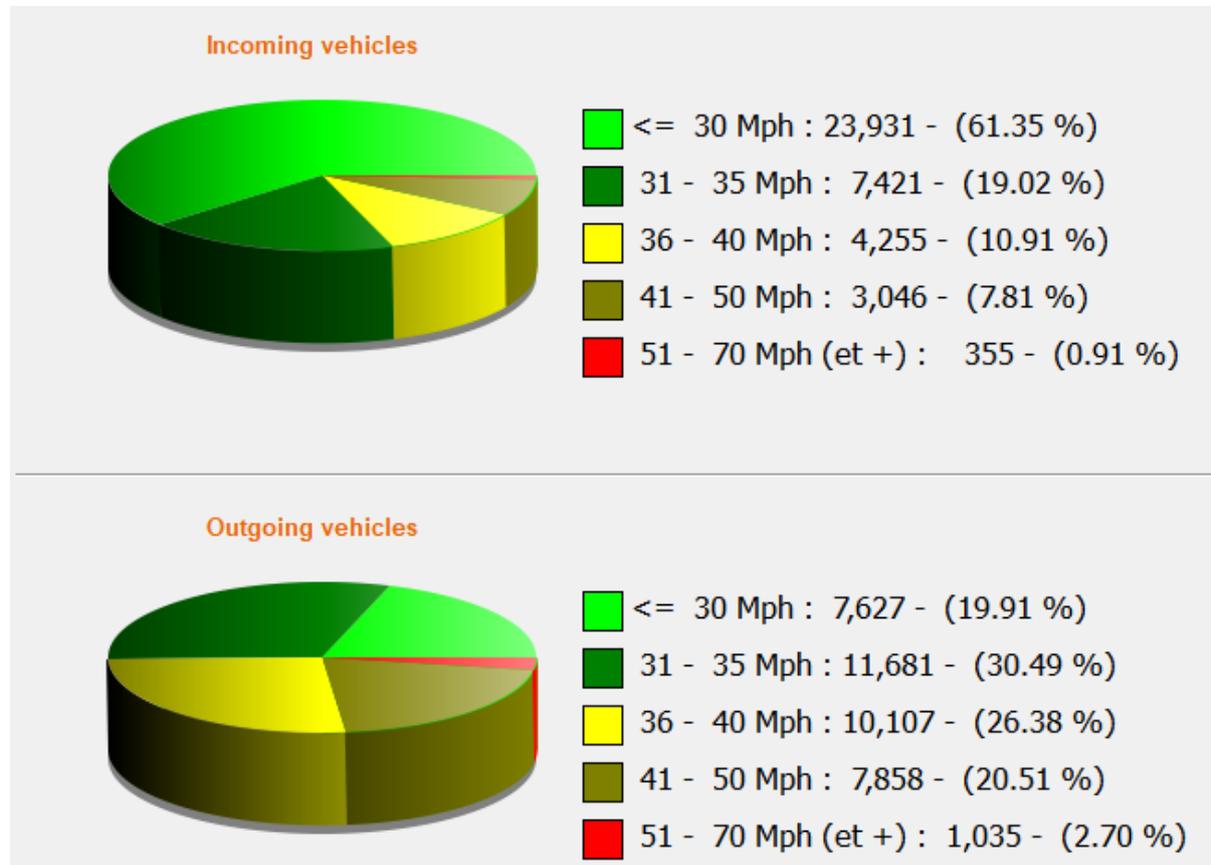
Chester Road

This has a different layout as the data is more limited.

The SID always faces eastbound vehicles entering Eccleshall (*incoming*), and also measures the speed of *outgoing* vehicles leaving the town westwards (who cannot see the SID).

Very low compliance when leaving the town. Given the location, within site of the end of the 30 MPH zone, this is not unexpected but is nevertheless very low.

Relatively low compliance (61%) when entering town, but over 80% traveling below 35 MPH. Over 8% of vehicles – more than 3,000 – are traveling at excessive speeds (over 40 MPH) at a point several hundred metres within the speed limit zone and passing the tennis and cricket grounds entrances.

It might be useful to investigate ways to further increase compliance for eastbound traffic (*incoming* vehicles), as that is the side of the road with the pavement.

It is not possible to evaluate whether the SID makes a difference, as we do not rotate the SID.

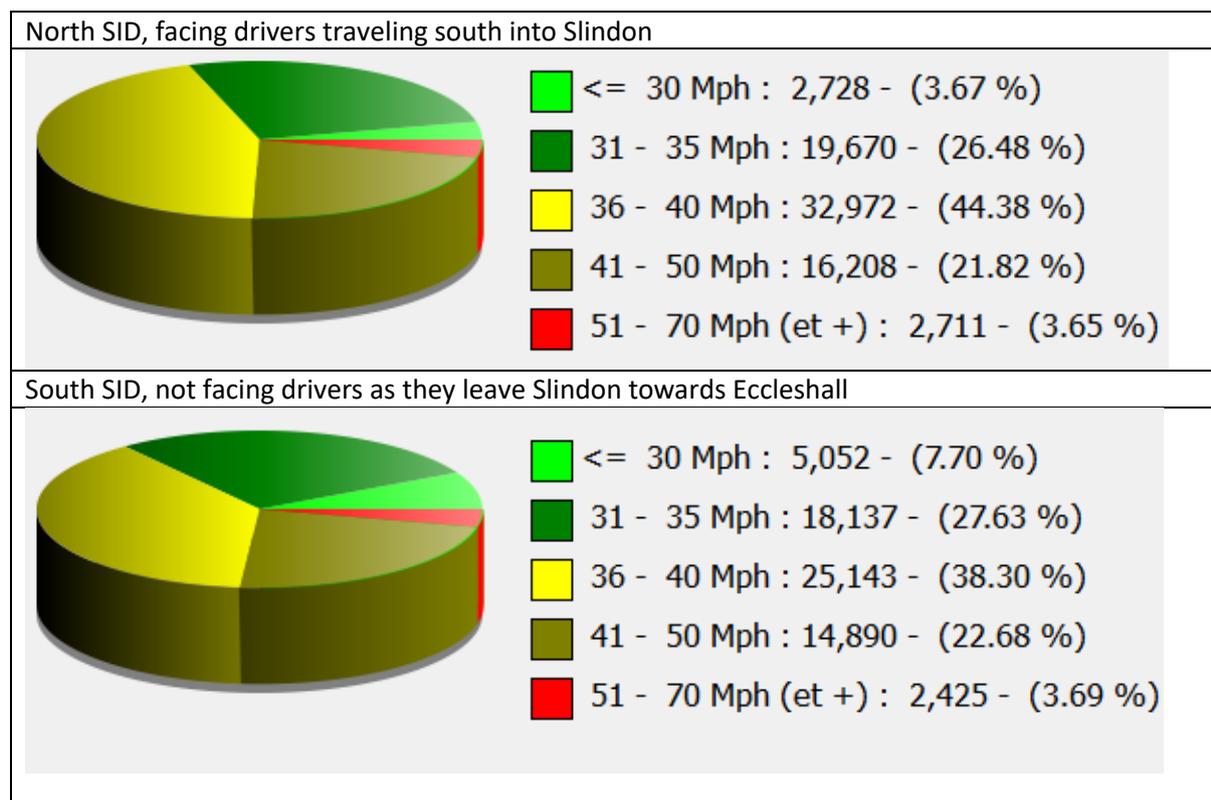
Slindon – vehicles traveling south

Two graphs showing vehicles traveling south (towards Eccleshall). The two SID locations are at either edge of the village, and so the North one is facing drivers as they enter the village while the South one is not facing drivers as they leave the village.

The data was recorded in different months, and so the number of vehicles do not tally.

The speed limit is 40MPH, and so green and yellow are in compliance. 'Excessive' would be over 50 MPH (red)

With 25% non-compliance, and nearly 4% excessive speeds, this is the least compliant location we have looked at. However, there is consistency in that vehicles that have reduced their speed at the first SID continue to obey until they leave the village.

It is not possible to evaluate whether the SIDs make a difference, as we do not rotate the SIDs.

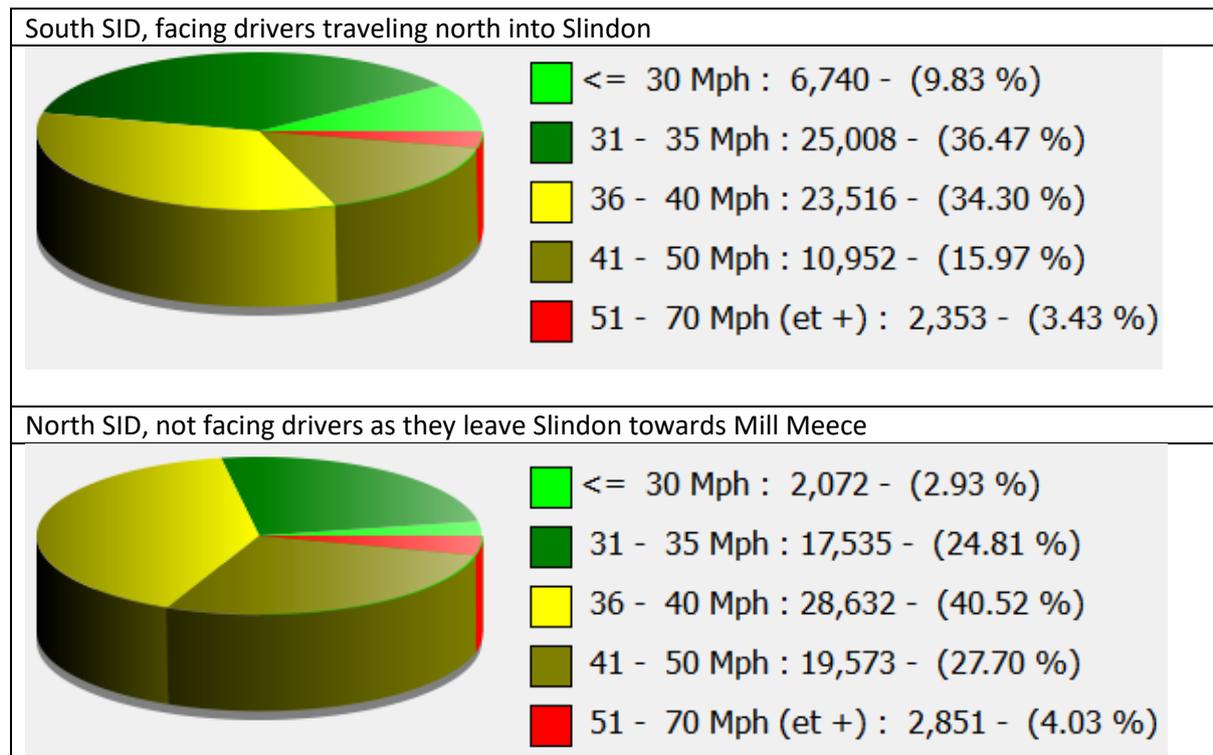
Slindon – vehicles traveling north

Two graphs showing vehicles traveling north (away from Eccleshall). The two SID locations are at either edge of the village, and so the South one is facing drivers as they enter the village while the North one is not facing drivers as they leave the village.

The data was recorded in different months, and so the number of vehicles do not tally.

The speed limit is 40MPH, and so green and yellow are in compliance. 'Excessive' would be over 50 MPH (red)

Less consistent results than the southbound data. With less than 2% non-compliance on entering the village but over 30% non-compliance when leaving the village, this shows that vehicle speed up as they approach the SID (which they cannot see as it is facing the other way).
